HALLS POND DAM

CT 00388

CT 00598

PHASE I INSPECTION REPORT

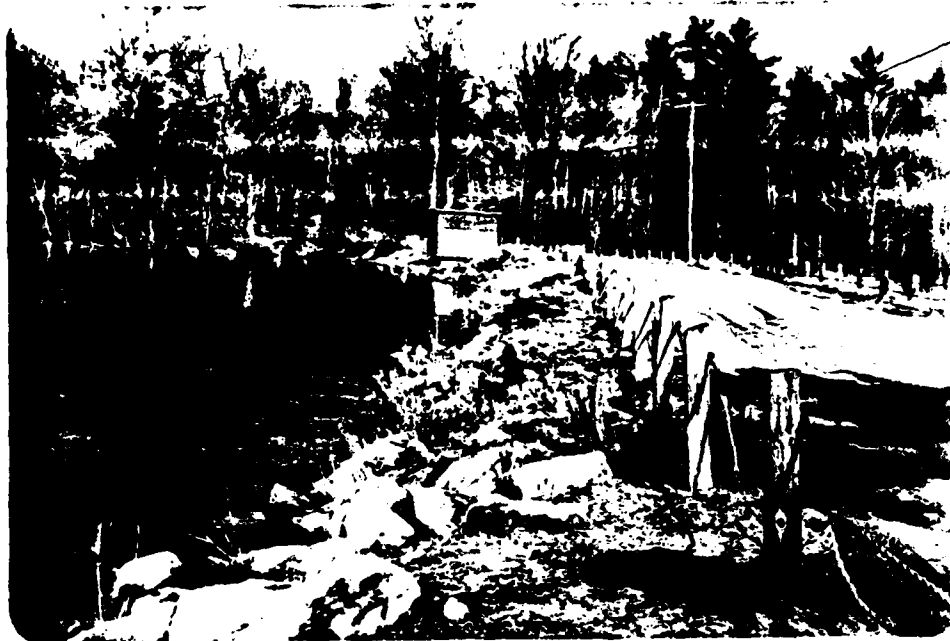
C1-1 UPSTREAM SLOPE

1. Upstream Face - The dumped rock fill is missing in some areas. There is minor brush growth, most of which has been trimmed as shown in Photos C1-1 and C1-6. There has been some erosion just south of the spillway, caused by storm runoff from the roadway.
2. Crest - The crest consists of Kennerson Reservoir Road which is an oiled gravel Town road. The road is in good condition, but the wire rope guide rail on the west side has been partially removed at the south end as shown in Photo C1-1.
3. Downstream Face - The downstream face is grass covered with some brush growth as shown in Photos C1-2 and C1-3. No seepage was observed.

1. Repair guide rail at south end of north dam.
2. Construct paved ditch to carry road water at spillway.
3. Paint all steel in gate house and repair lock on door.
4. Repair riprap at both dams.
5. Check operation of gate on a regular basis.

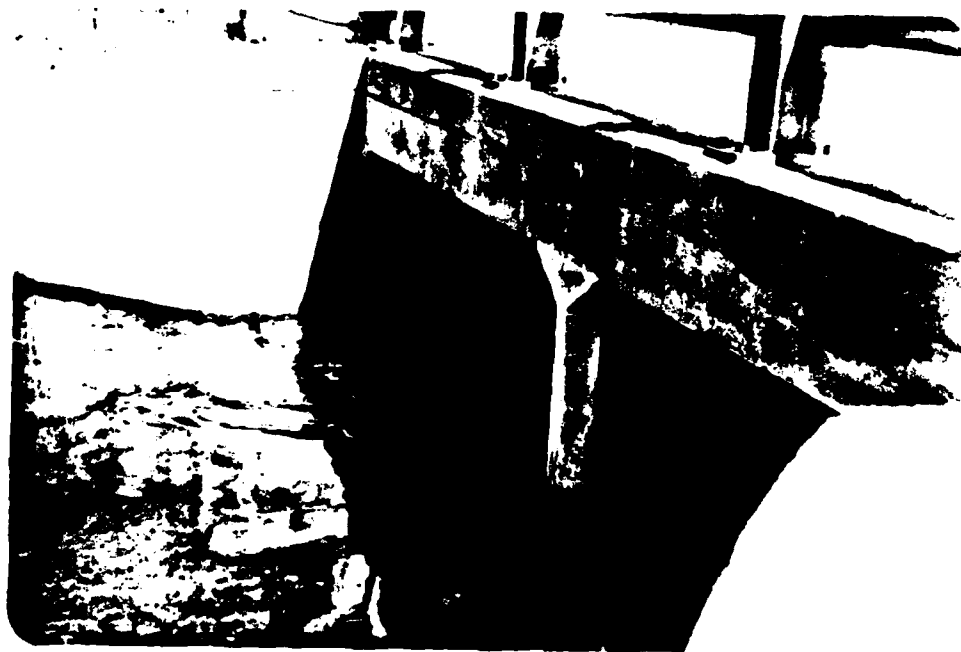
C1-4 UPSTREAM END OF SPILLWAY

1. Spillway - Twin 9'x3.3' cast-in-place concrete box culverts constructed in 1968 form the spillway with a concrete channel on a 2H:1V slope for an outlet channel. Photos C1-4 and C1-5 show the spillway and channel. The spillway is in good condition except for a crack at the wingwall at the northwest corner as shown in Photo C1-4. This crack should be investigated further.

- a. Investigate areas of seepage in the downstream face of the south dam to determine if repairs are warranted.
- b. Investigate the crack in the box culvert spillway at the northwest corner to determine if repairs are warranted.

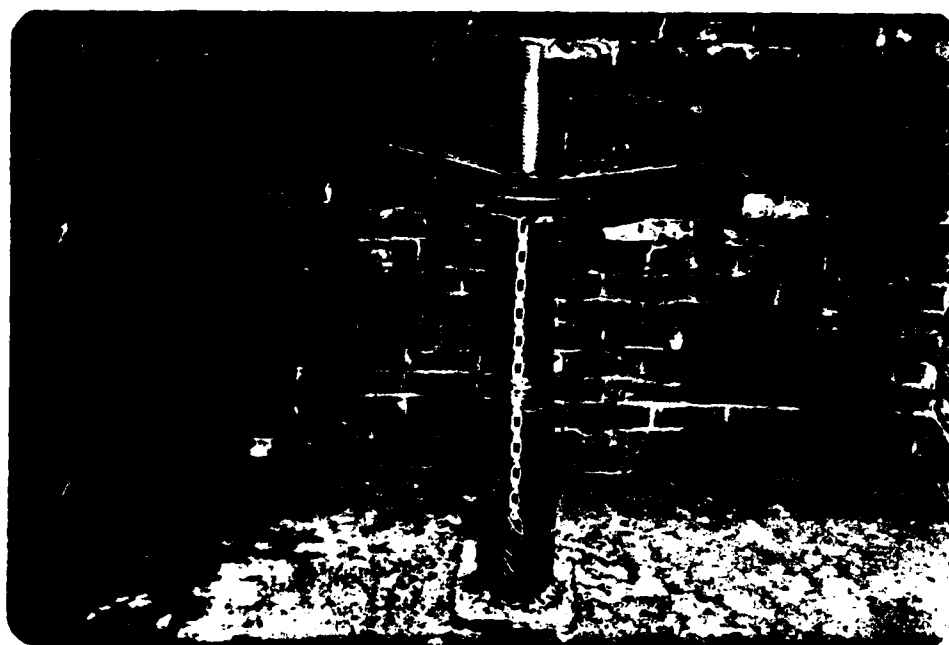
C1-8 GATE CONTROL WHEEL

| AREA EVALUATED | CONDITION |
|---|--|
| Service Gates | Some rusting of control wheel not secured from unauthorized use. |

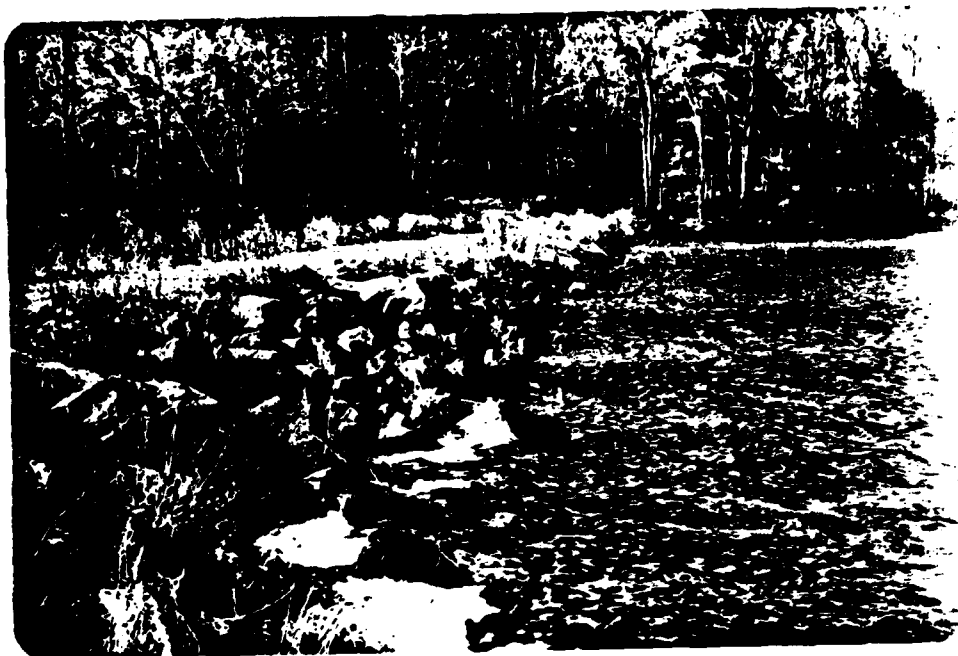
C2-3 UPSTREAM FACE

1. Upstream Face - The upstream face has dumped rock fill which is missing in some areas as shown in Photos C2-3 and C2-4. There is minor erosion from wave action.
